## ABRASION TEST

### Sandblasting of NORSelast® plates

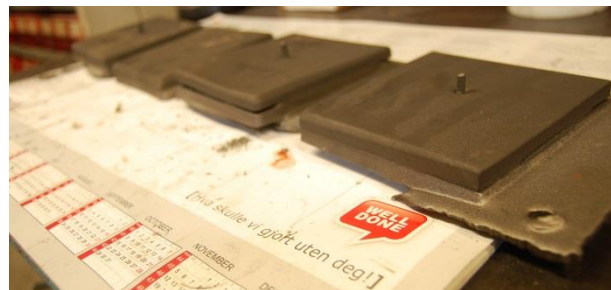
After seven weeks of production at a three shift schedule the testplates had been exposed to sandblasting for almost 700 hours. The Hardox plate was showing severe abrasion. The pictures are clearly showing that NORSelast® not only protected the steel which was covered, but hardly showed any sign of abrasion at all. The dimension was almost intact, and only the edges did show some sign of wear.

Four testplates in moulded NORSelast® with hardness 90 Shore A and thickness of 10mm was mounted on a Hardox steelplate. This was then put inside the sandblasting machine at Ramco Norway AS i Florø. The plate was welded to the wall in the area which receives all the sand from the production. Hardox is special steel which is very abrasion resistant.
